IN-SERVICE PERFORMANCE EVALUATION OF THE BULLNOSE MEDIAN BARRIER IN THE STATE OF IOWA

Malcolm H. Ray
Associate Professor

Jennifer A. Weir
Associate Research Engineer

ABSTRACT

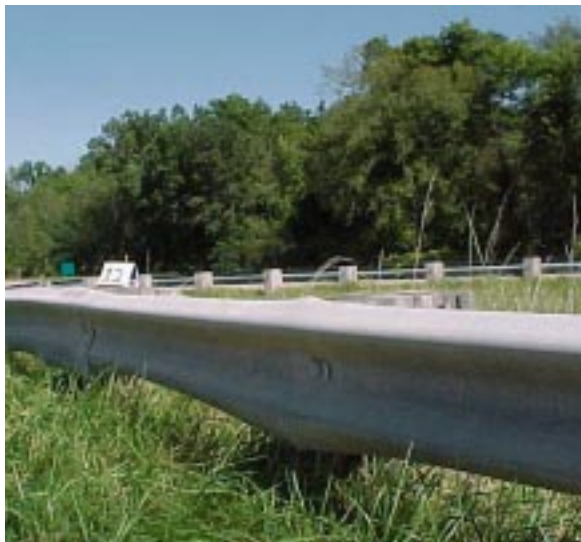
however, which sometimes might include minor damage to a guardrail that was never reported, such as that shown in Figure 3. **Figure 3. An example of minor guardrail damage.**

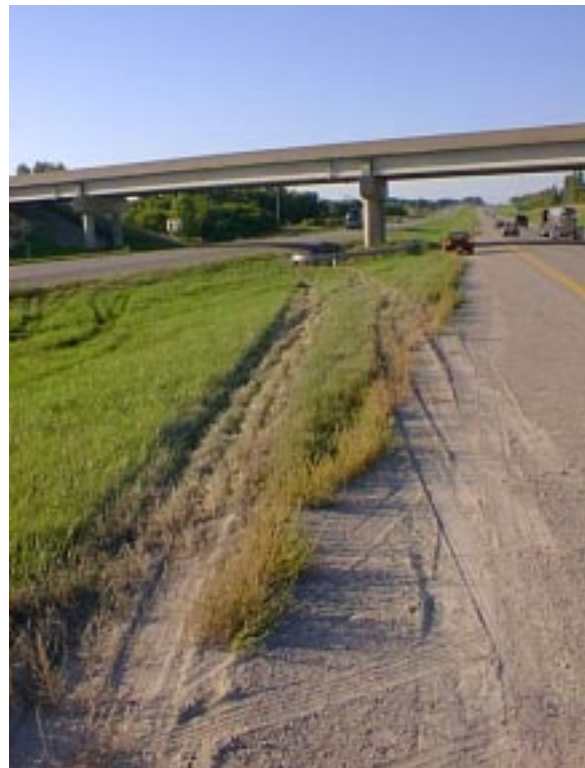
The first nose impact (case I97090401) involved a Freightliner dump truck that lost control due to a blown tire, penetrated the nose of the system, and continued through the guardrail from behind, across the opposing lanes, and into a ditch, where it rolled over. The driver, who was the only occupant, suffered major head injuries. Repairs to the guardrail cost \$2205. Figure 5 shows the repaired bullnose and the tracks of the dump truck heading toward the nose.

Figure 5. Vehicle approach path in an end-on collision (Case I97090401).

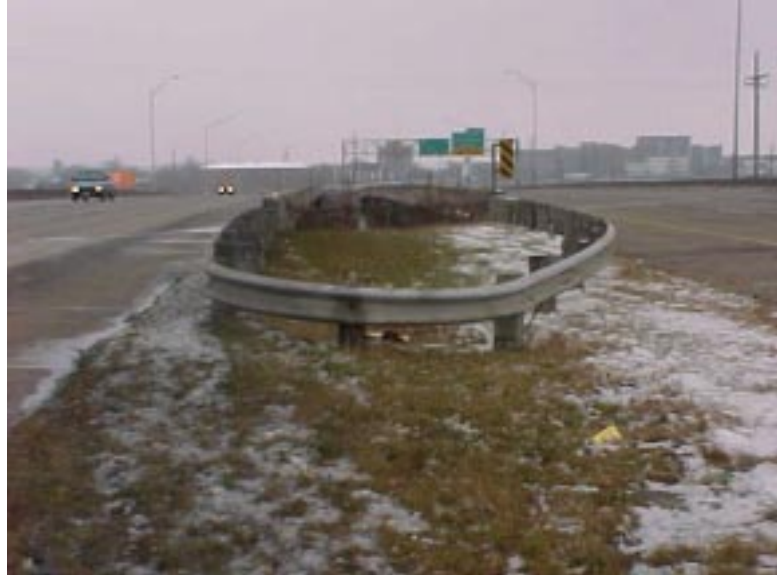
The other nose collision (case I98060502), which occurred in the rain, involved a passenger car that was stopped in contact with the bullnose. The driver, who was the only occupant, suffered multiple major injuries. Repairs to the guardrail cost \$1390. Figure 6 shows the repaired bullnose in this case.

Figure 6. Repaired bullnose after an end-on collision (Case I98060502).

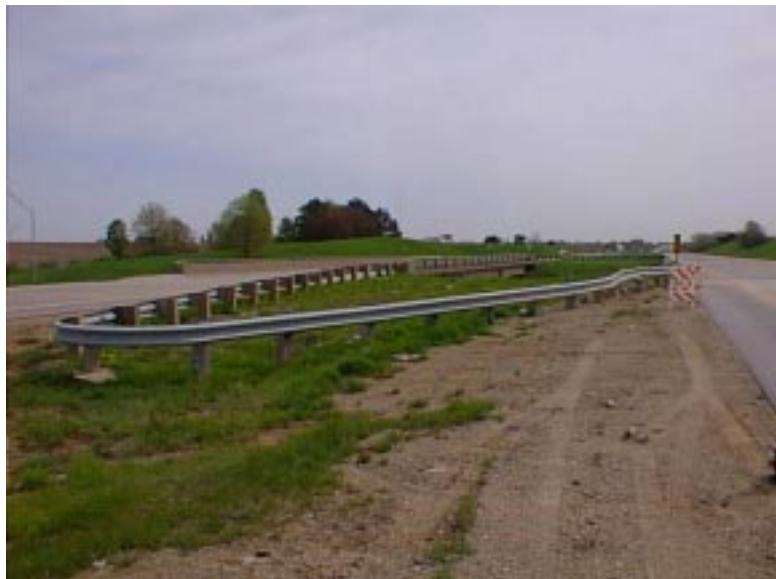
The first bullnose transition collision (case I98042701) involved a Ford F350 pickup that hit the bullnose and was redirected across both lanes of traffic into a bridge railing on the other side of the roadway. The driver and right rear passenger suffered major injuries to the upper torso, and the other two passengers suffered minor injuries to the upper torso. The cost to repair the guardrail was \$746. Figures 7 and 8 show the bullnose after this collision.

Figure 7. Vehicle approach path (Case I98042701).

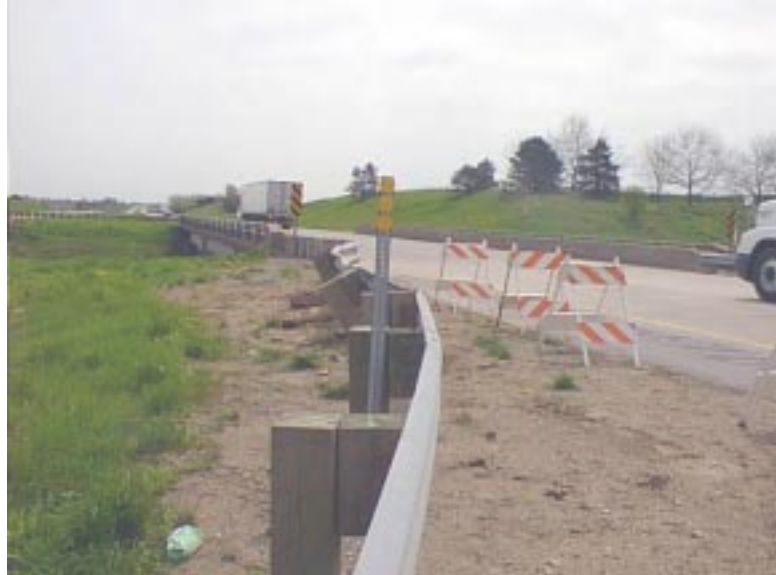
Figure 8. Bullnose damage (Case I98042701).

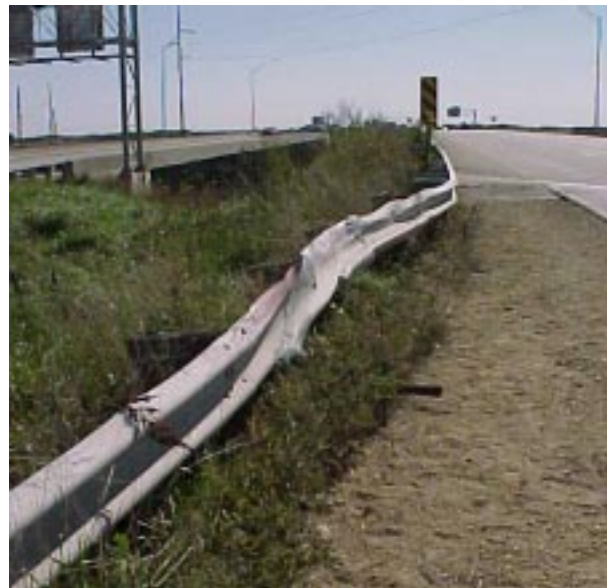
Figure 9. Case I98092303

The next bullnose transition collision (I98092303) was an unusual collision in which the driver of a car lost control and spun around in the roadway. The vehicle slid backwards and hit the guardrail on the passenger side going backwards. The vehicle vaulted over the rail and flipped over, finally coming to rest on a railroad track below the twin bridges. The four occupants were injured severely, and the right rear passenger later died from his injuries.

9 shows the damaged guardrail and Figure 10

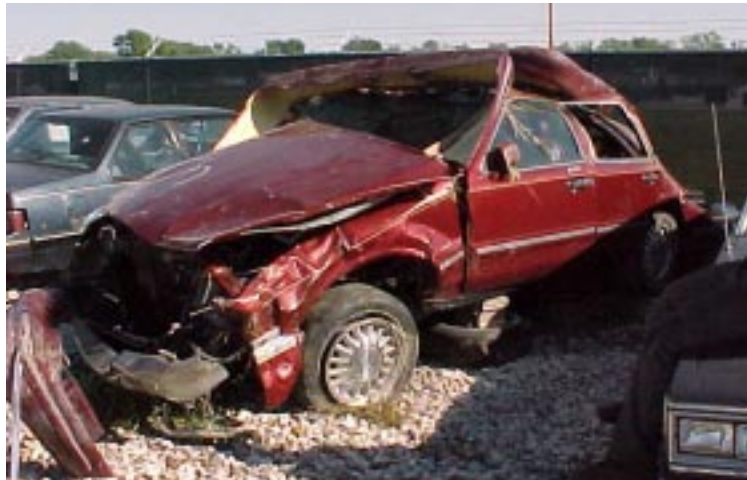
Figure 10. Vehicle after collision (Case I98092303).

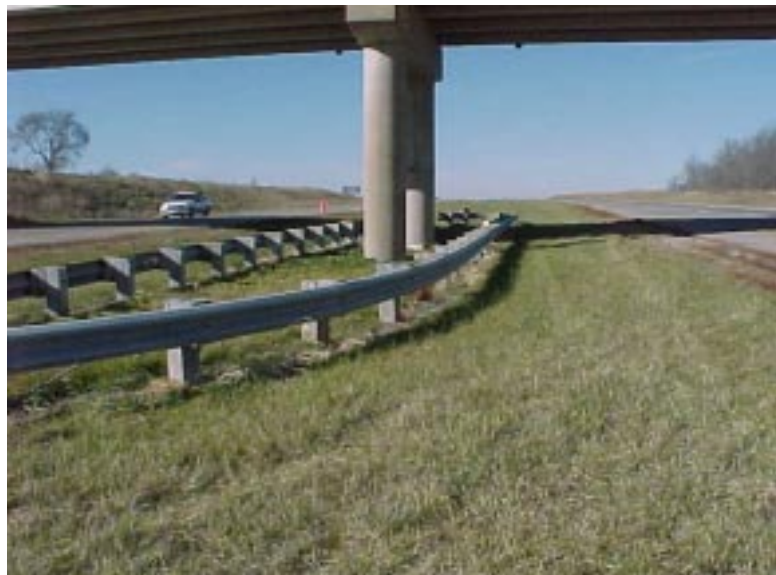
Figure 11. Case 98112601

The last bullnose transition collision (case I98112601) involved a pickup that penetrated the guardrail and hit a bridge pier. Two passengers suffered multiple major injuries, the driver and three other passengers suffered minor injuries, and the vehicle was destroyed. The total cost to repair the guardrail was \$644. Figure 11 shows the repaired guardrail.
