**IN-SERVICE PERFORMANCE EVALUATION OF THE
BULLNOSE MEDIAN BARRIER IN THE STATE OF IOWA**

Malcolm H. Ray, Associate Professor
Jennifer A. Weir, Associate Research Engineer

Transportation Research Board
80th Annual Meeting
January 7-11, 2001
Washington, D.C.

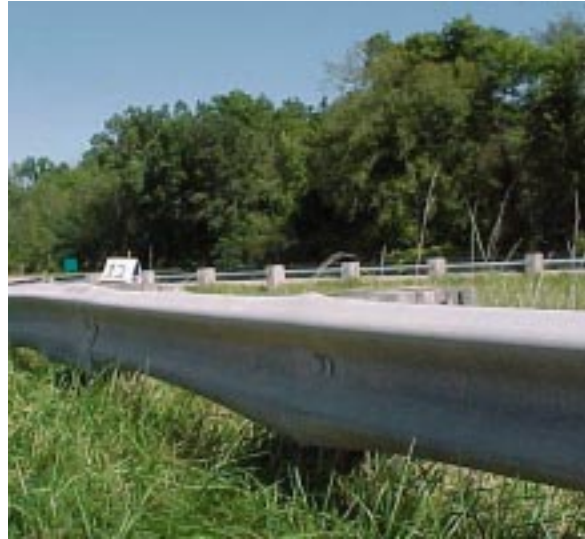
roadside appurtenance is repaired as a result of a collision. Even if the collision is not reported to the police, a Cost Memo is filed so that if a collision is subsequently linked to the damage or the responsible party is identified the cost can be documented. A cost report is not filled out for routine maintenance, however, which sometimes might include minor damage to a guardrail that was never reported, such as that shown in Figure 3.

Figure 3. An example of minor guardrail damage.

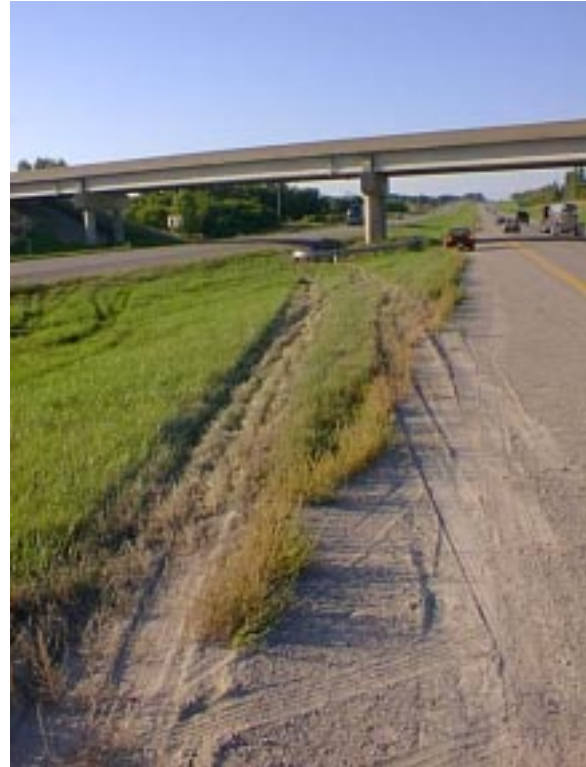
The first nose impact (case I97090401) involved a Freightliner dump truck that lost control due to a blown tire. The vehicle penetrated the nose of the system, continued through the guardrail from behind, across the opposing lanes and into a ditch where it rolled over. The driver, who was the only occupant, suffered major head injuries. Repairs to the guardrail cost \$2,205. Figure 5 shows the repaired bullnose and the tracks of the dump truck heading toward the nose.

Figure 5. Vehicle approach path in an end-on collision (Case I97090401).

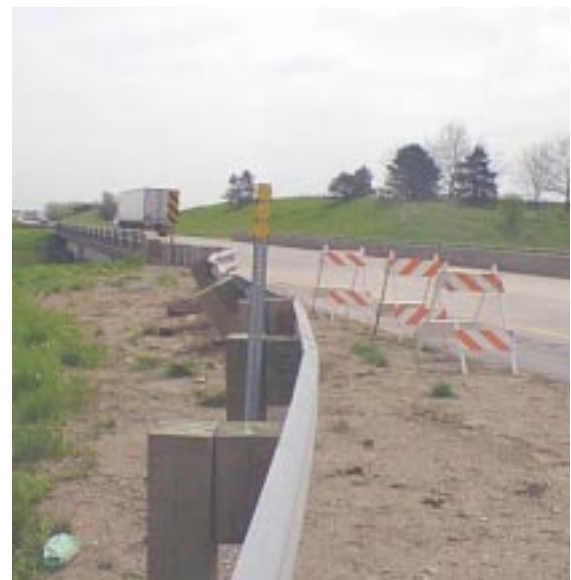
The first bullnose transition collision (case I98042701) involved a Ford F350 pickup that hit the bullnose and was redirected across both lanes of traffic into a bridge railing on the other side of the roadway. The driver and right

rear passenger suffered major injuries to the upper torso, and the other two passengers suffered minor injuries to the

Figure 6. Bullnose damage (Case I98042701).

upper torso. The cost to repair the guardrail was \$746. Figure 6 shows the bullnose after this collision.

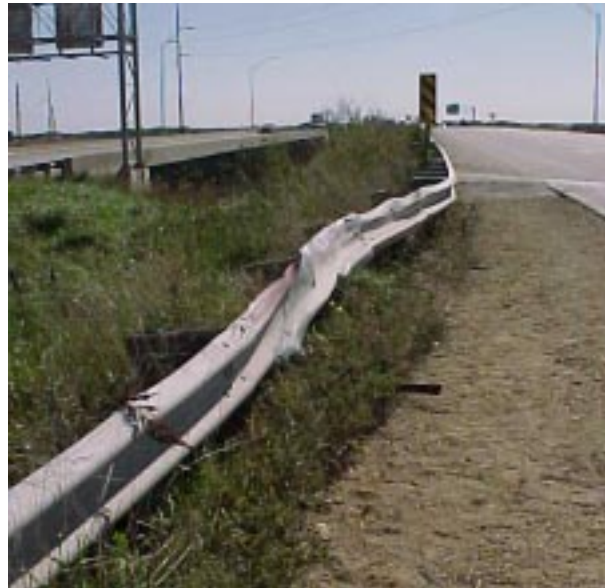
Figure 7. Case I98092303

The next bullnose transition collision (I98092303) was an unusual collision in which the driver of a car lost control and spun around in the roadway. The vehicle slid backwards and hit the guardrail on the passenger side going backwards. The vehicle vaulted over the rail and flipped over, finally coming to rest on a railroad track below the

twin bridges. The four occupants were injured severely, and the right rear passenger later died from his injuries. He had not been wearing his seatbelt. Repair costs from this collision are not known. Figure 7 shows the damaged guardrail.
